Offset Frontal Collisions and the Effect on Opposite Side Occupants

Using Crash Data to Identify People with
Critical Injuries that are Difficult to Detect

Jeffery Augenstein, Kennerly Digges,
James Stratton, Elana Perdeck

The William Lehman Injury Research Center

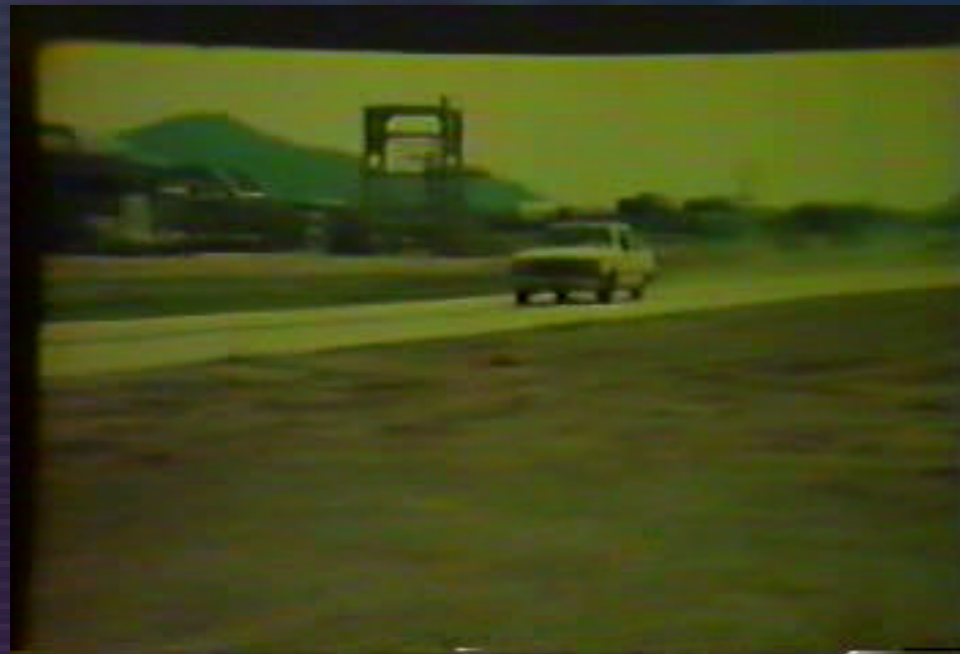
Off-side Frontal (Driver)

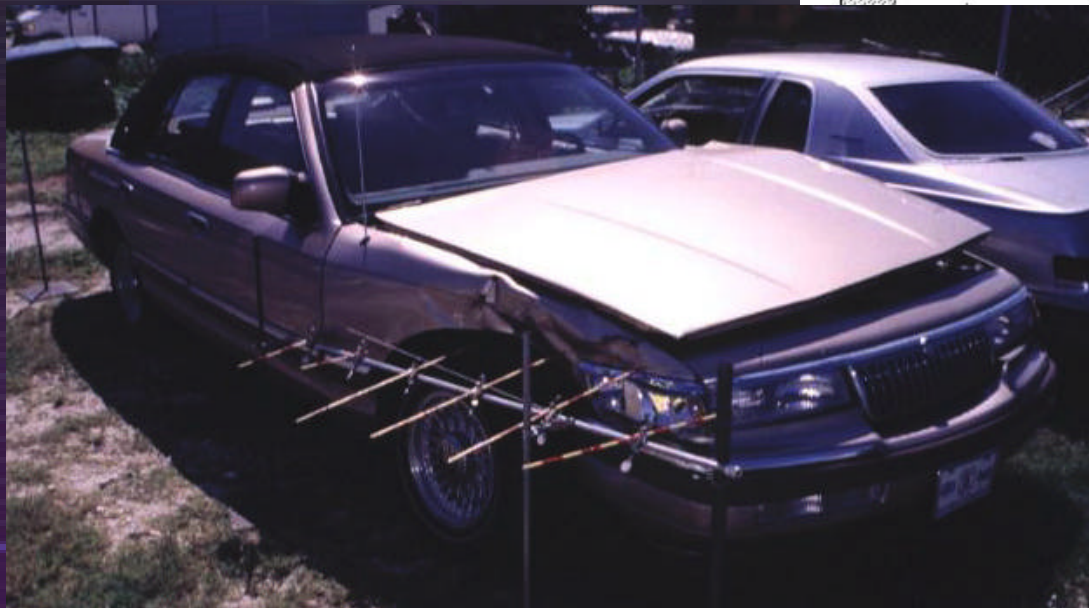
Case 98-006BL

9 mph Crash - Fatality

- 2 o'clock, 9 mph
- '93 Mercury Marquis

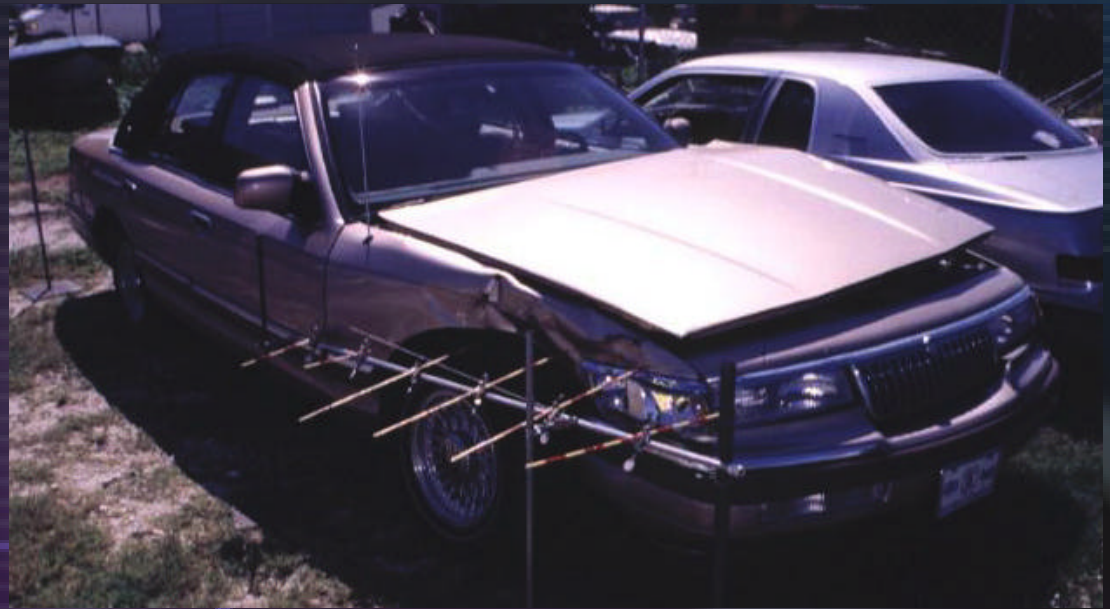
Case 98-006BL

9 mph Crash - Fatality

- Male Driver; 77 YO; 68" Tall; 272 Lbs
- Veh. - '93 Mercury Marquis
- POV- '97 Buick LeSabre
- 2 o'clock, 9 mph
- 10" Max Crush
- No Intrusion

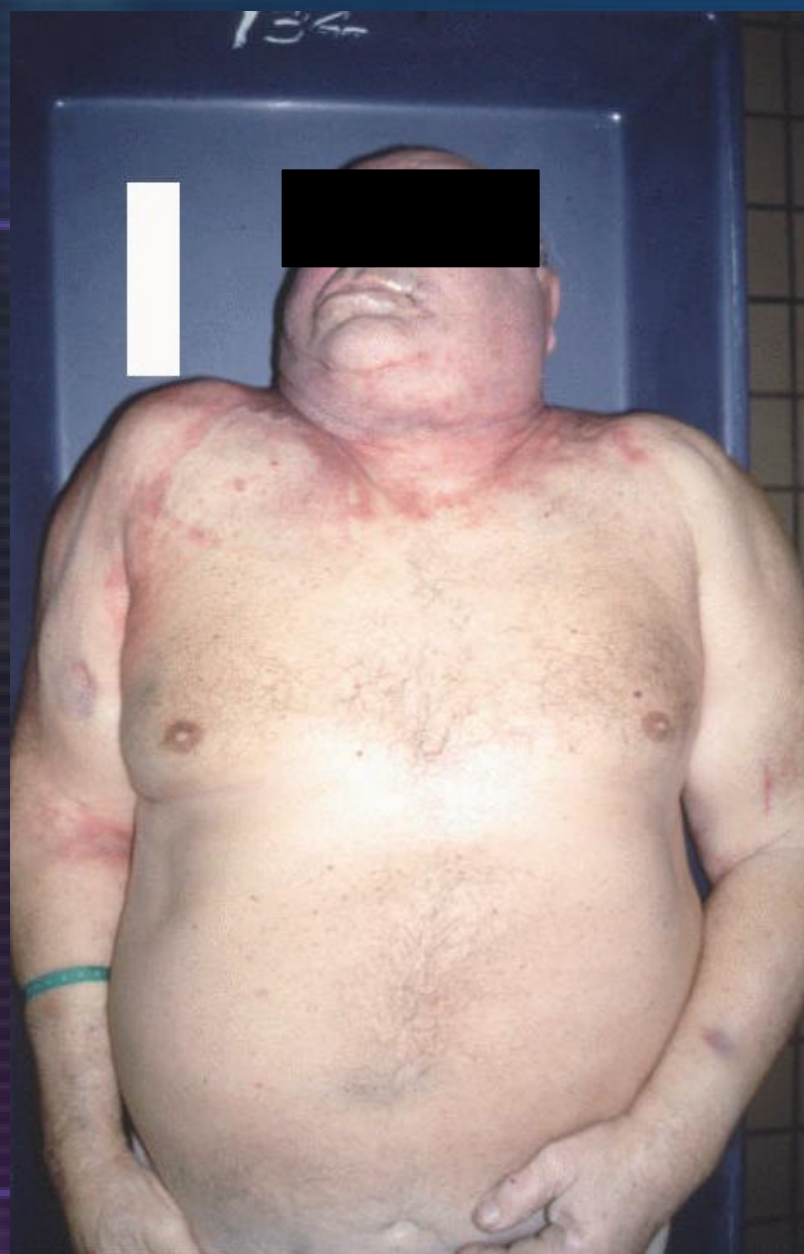
Case 98-006BL

9 mph Crash - Fatality

Upper Body
Markings

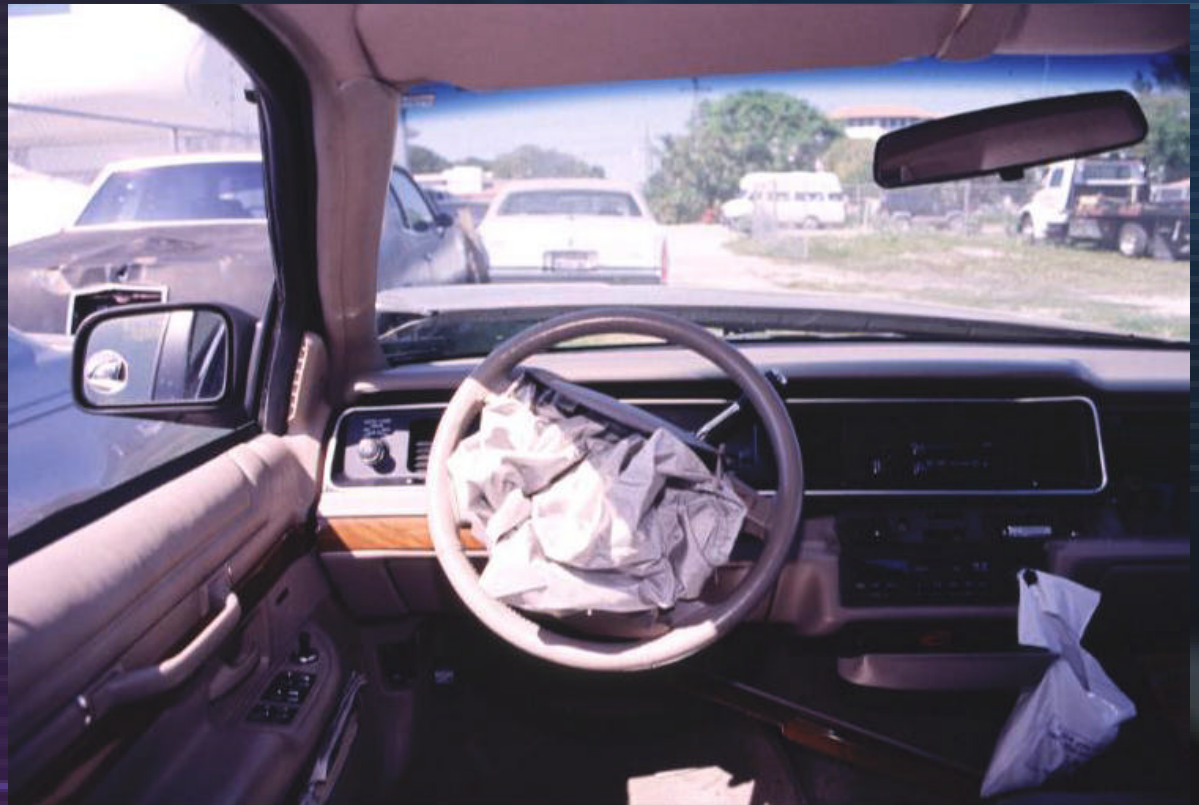
Case 98-006BL

9 mph Crash - Fatality

- Trauma Criteria - Expired at Scene
- Restraints-
Lap & Shoulder
Belt
Air Bags Deployed

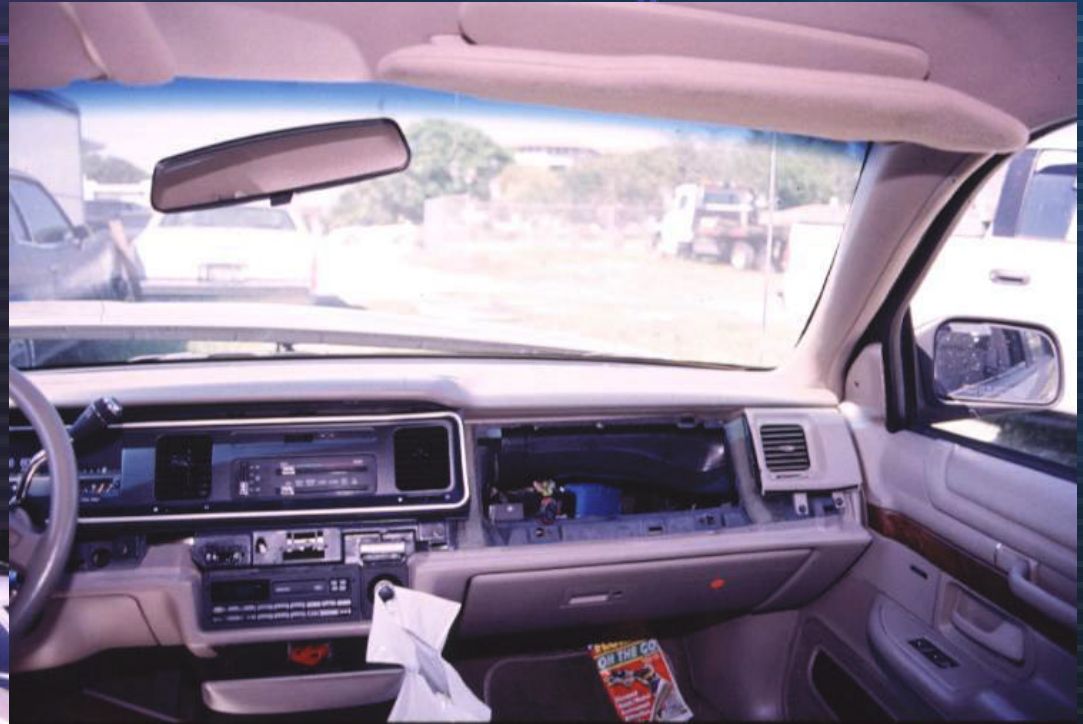
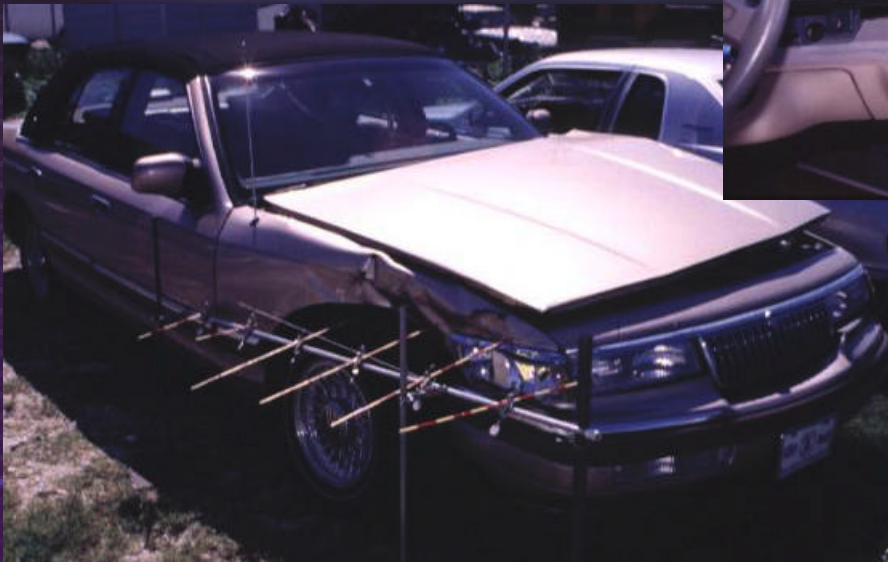
University of MIAMI
Case 98-006BL

9 mph Crash - Fatality

AIS-5 Brain Injury
Passenger Air Bag
Contact

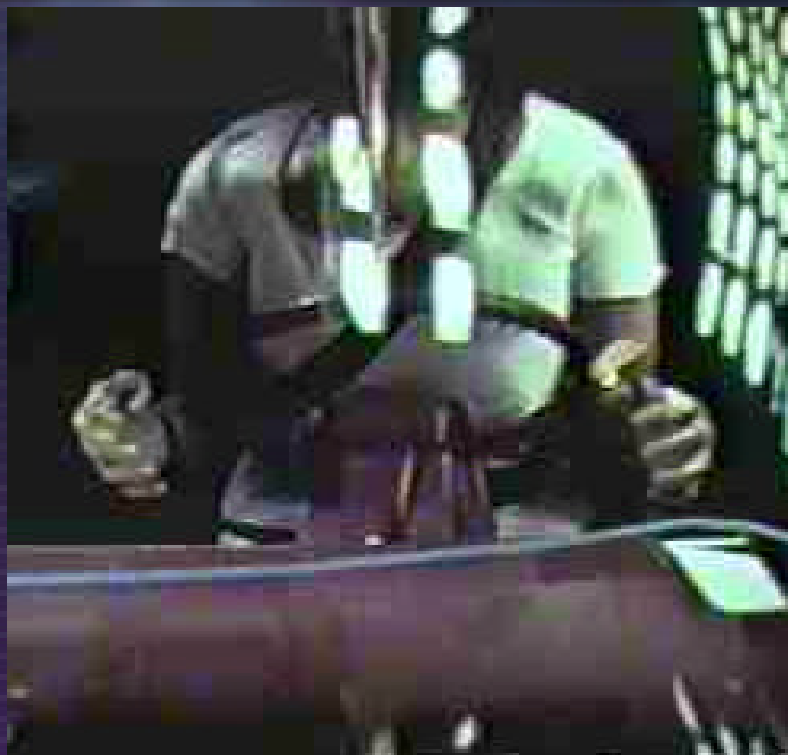
Belt Geometry Comparison

3-Pt Belt

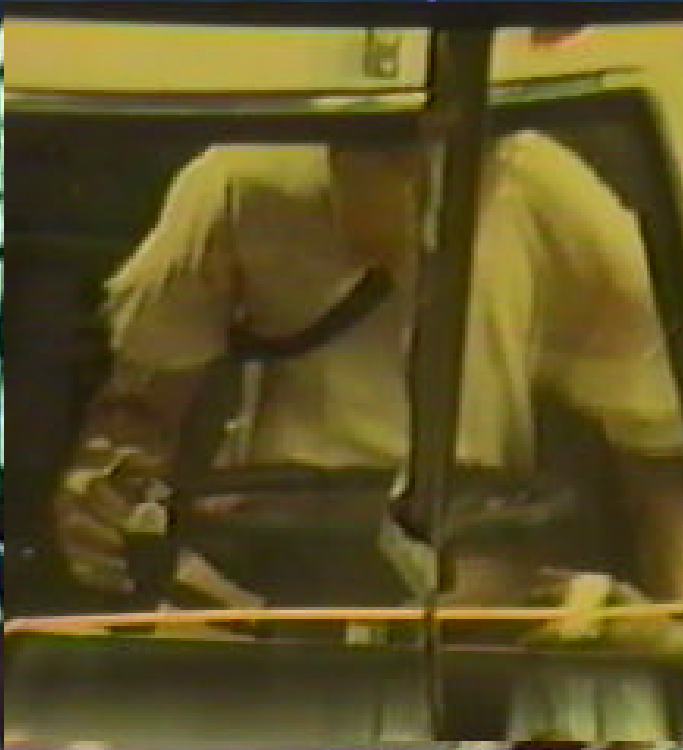
2-Pt Belt
University of MIAMI

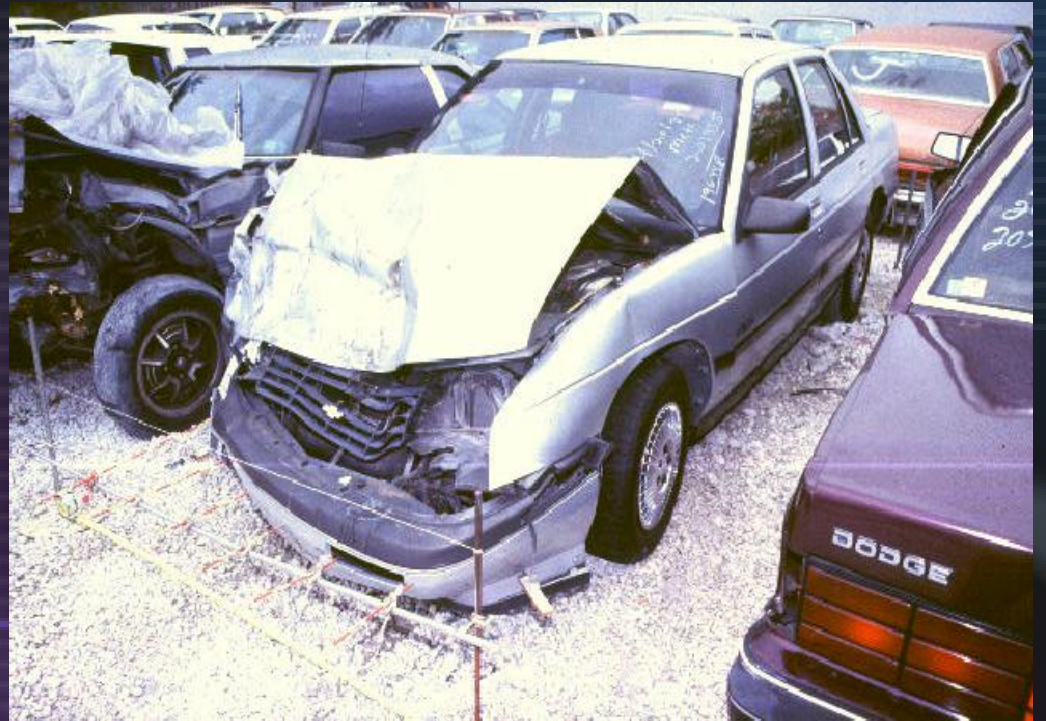
Case #95-012

Vehicle Damage

- Case Vehicle: 1988 Chevrolet Corsica
- PDOF: 1 O'clock
- DeltaV: 20.6 mph
- Max Crush: 12.5"
- Type: Frontal Offset
Vehicle to Vehicle

- POV: 1989 International
School Bus

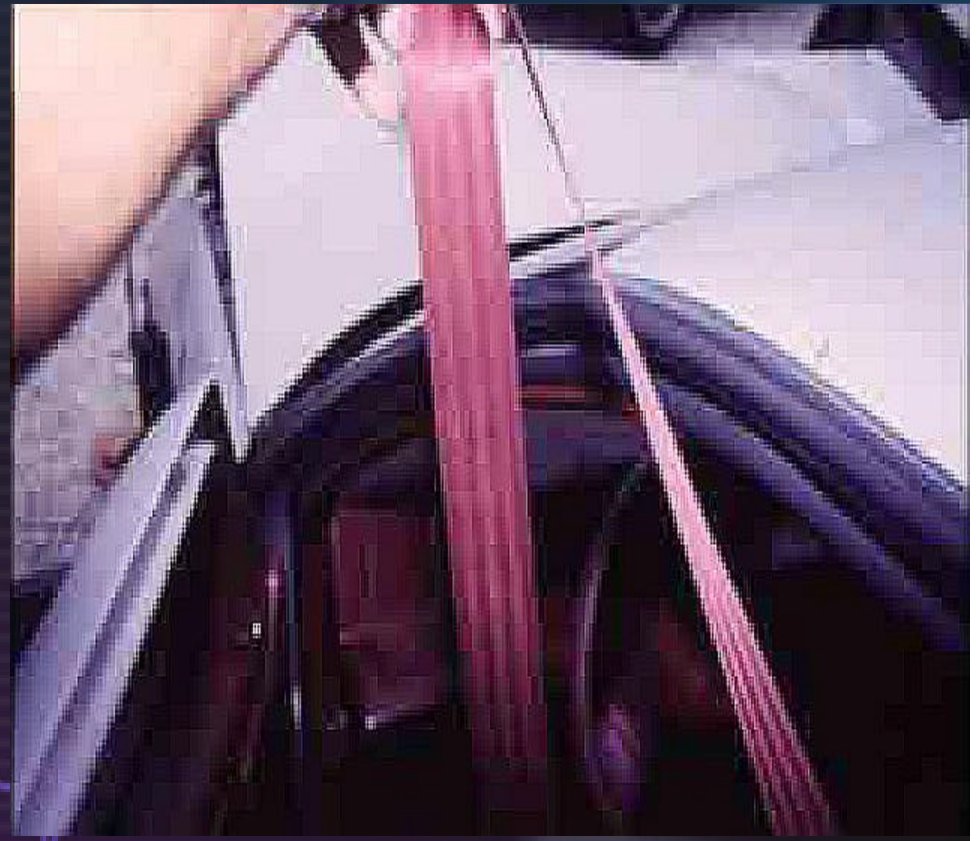
Case #95-012

Injuries

Belt Restraint

- Contusion, Heart AIS-3
- Contusion, Chest, Right AIS-1
- Abrasion, Neck, Anterior AIS-1

Toe Pan

- Fx Malleolus, Left Posterior AIS-3
- Fx Malleolus, Left Medial AIS-2
- Fx Fibula, Left AIS-2
- Fx Fibula, Right AIS-2
- Fx Malleolus, Right Medial AIS-2

- Heart Contusion In 70 Year Old Female
- Multiple Lower Extremity Fractures
Compounds Rehabilitation For Elderly

- Restraint System Too Stiff For Elderly
Results In Heart Contusion
- Good Outcome For Elderly Driver
Length Of Stay 11 Days
- Off-side Frontal Crash

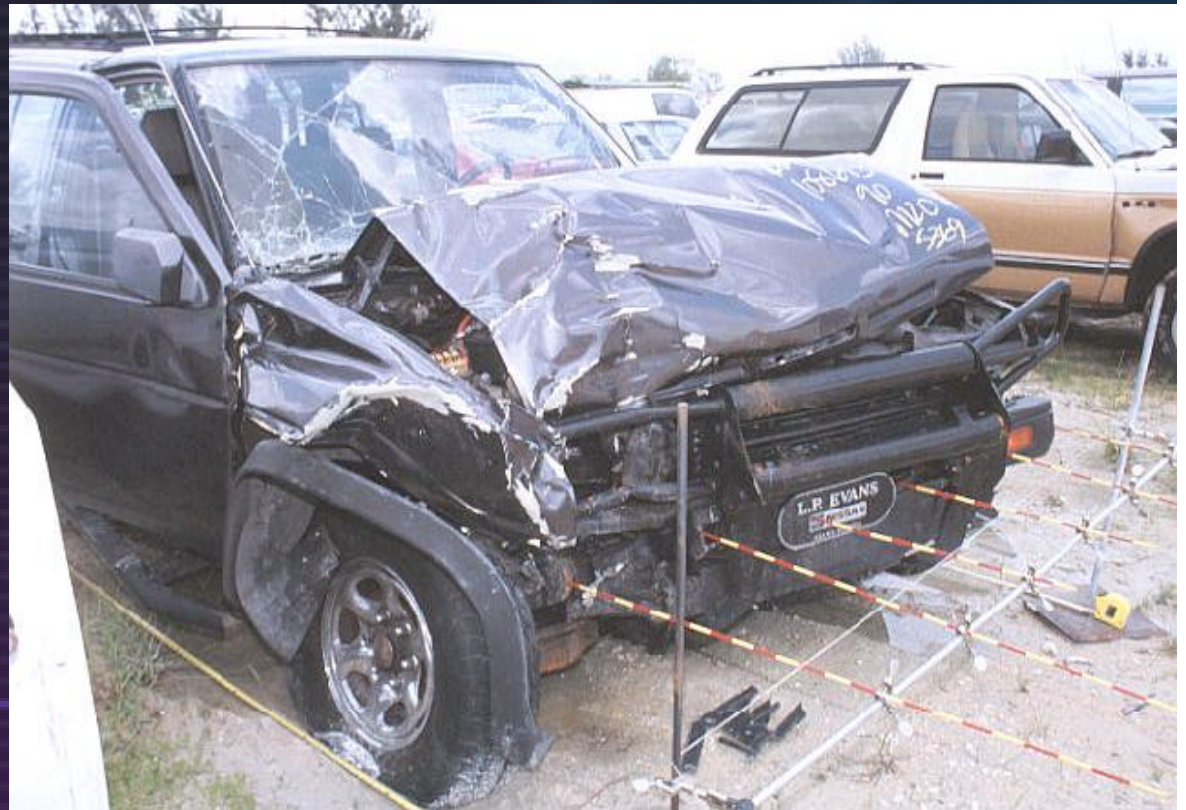
Case #98-017

Vehicle Damage

- Case Vehicle: 1990 Nissan Pathfinder
- PDOF: 1 O'clock
- DeltaV: 26 mph
- Max Crush: 23"
- Type: Frontal Offset
Vehicle to Vehicle
- POV:
1987 Toyota Camry

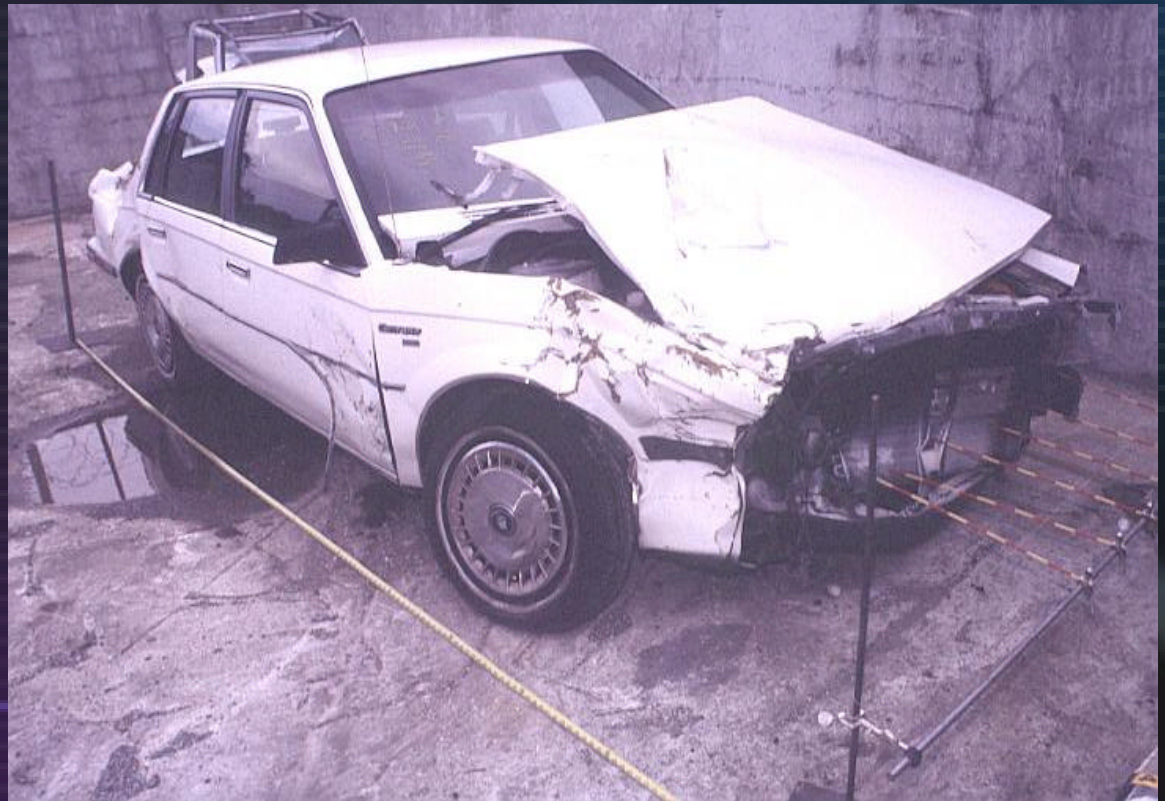
Vehicle Damage

- Case Vehicle: 1987 Buick Century
 - PDOF: 1 O'clock
 - DeltaV: 24 mph
 - Max Crush: 11"
 - Type: Frontal Offset
Vehicle To Vehicle
 - POV:
 - 1987 GMC Jimmy
- Case #98-046

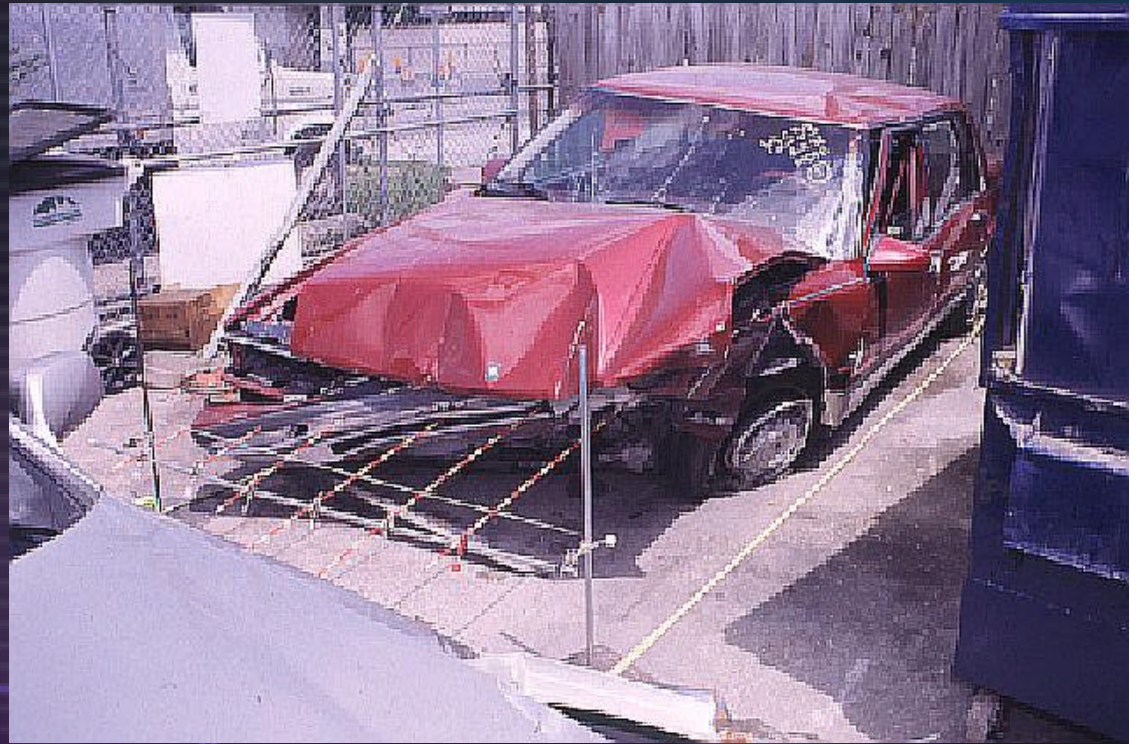
Case #98-011

Vehicle Damage

- Case Vehicle: 1989 Oldsmobile 98
- PDOF: 11 O'clock
- DeltaV: 25 mph
- Max Crush: 33"
- Type: Frontal Offset
Barrier Impact

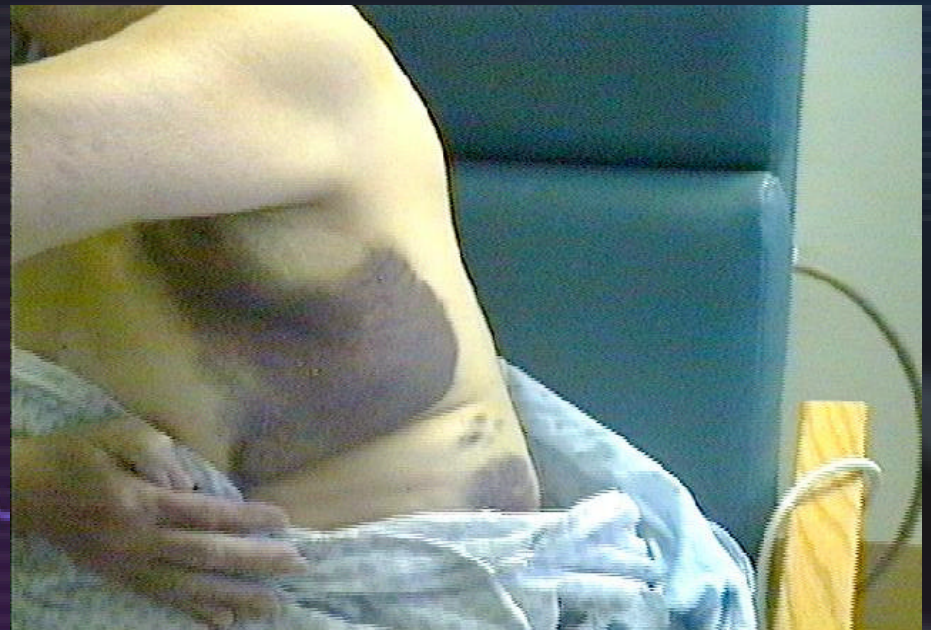
Case #98-011

Injuries

Belt Restraint

- Fx Thyroid Cartilage AIS-2
- Fx Arytenoid Cartilage AIS-2
- Abrasions/Contusions, Multiple AIS-1

Toe Pan

- Fx Malleolus, Media, Left AIS-2
- Fx Fibula, Distal, Left AIS-2

- Multiple Left Lower Extremity Injuries
- Neck Injuries From Belt Loading

- Restraint Geometry Unfavorable To Short Female
Resulted In Neck Injury
- Barrier Impact Crash Produced Clockwise Rotation
Increased Belt Load On Right Front Passenger
- Moderate Speed Impact With Favorable Results For
Passenger
Discharged In 9 Days
- Off-side Frontal Crash
